SEISMIC REHABILITATION OF AN EXISTING PRE-1940 BUILDING. CASE STUDY

SUMMARY

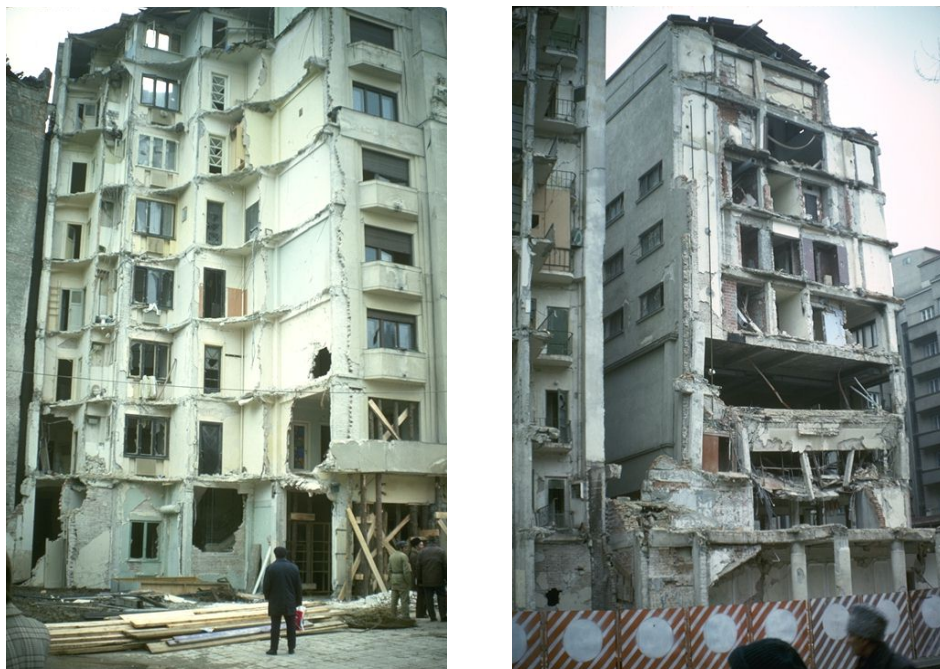
Figure 1: Pre-1940s medium and high-rise buildings that partially collapsed during the earthquake on March 4, 1977 (<http://nisee.berkeley.edu>)

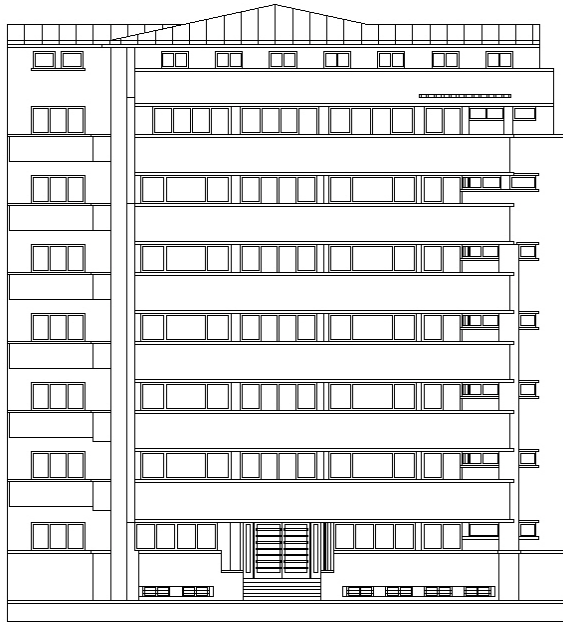
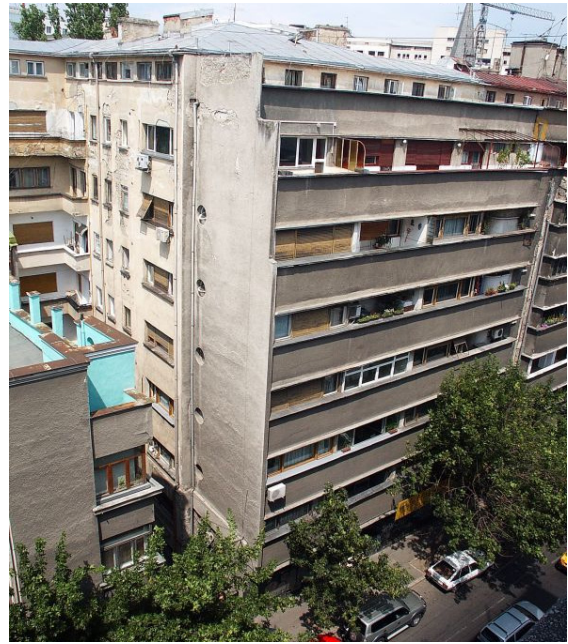
The building has an irregular shape both in plan and elevation (Figure 2). It resulted from the architectural restrictions imposed by the neighbouring buildings and the actual shape of the plot of land. The top story and wooden roof levels have setbacks of almost 2.00m and 5.00m, respectively, from the main faade facing the Știrbei Vodă Street (see figure 2).

Figure 2: Main faade of the building facing the tirbei Vodă Street

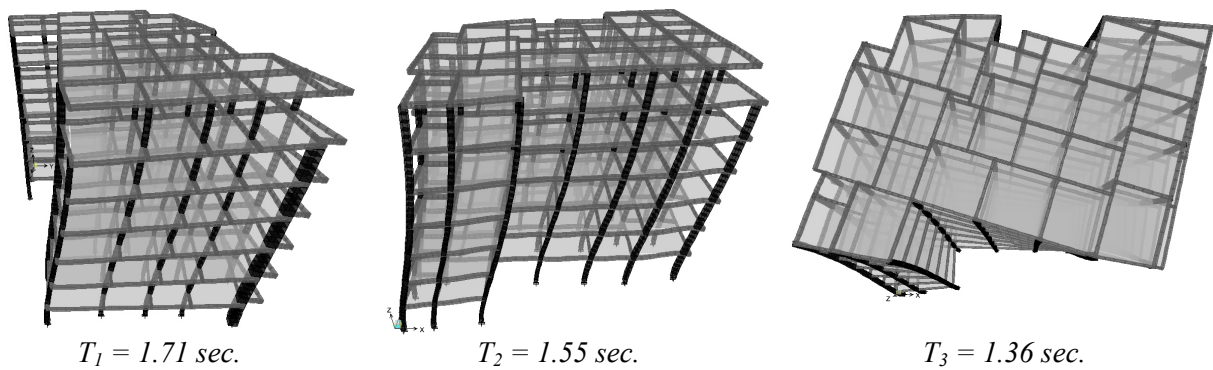
Due to the considerable stiffness and geometrical irregularities, a 3D model of the structural system was created. The results of the modal analysis showed that the structural system is very flexible. Because of this characteristic, the structure experienced large lateral displacements in the previous earthquakes that caused severe damages to the brick masonry walls and RC elements. As can be seen in figure 6, the first period of vibration of 1.71 sec. corresponds to a combination of translation along Stirbei Voda St. with torsion. The second mode of vibration that corresponds to almost pure translation perpendicular to the main façade has a vibration period of 1.55 sec.

Figure 6: First three eigen-modes of the structural model

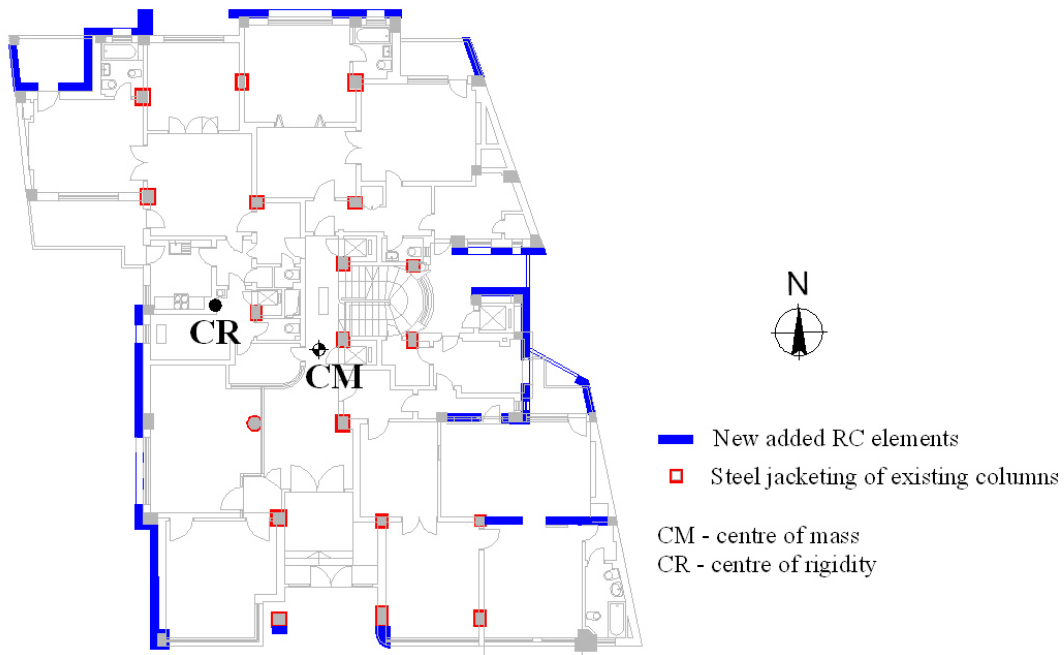
Figure 9: Plan of the strengthening solution

- Introducing new exterior reinforced concrete frames and structural walls on the eastern, western and northern façades (see figure 9), on the entire height of the building. All the dimensions and positions of the existing windows and technological openings will be kept exactly as they are. The concrete class for these new elements will be C25/30 and they will be properly connected to the existing structure through reliable post-installed chemical anchors.

- Replacing two interior brick masonry walls with new reinforced concrete shear walls from the basement up to the sixth story. The boundary RC columns will be retrofitted and they will be adequately fastened to the new reinforced concrete web.

- Retrofitting most of the interior RC columns by steel jacketing in order to increase their axial capacity. The columns will be retrofitted from the basement level up to the fourth story.

- Adding a new foundation system for the new exterior RC elements and enlarging the existing foundations under the new interior RC shear walls.

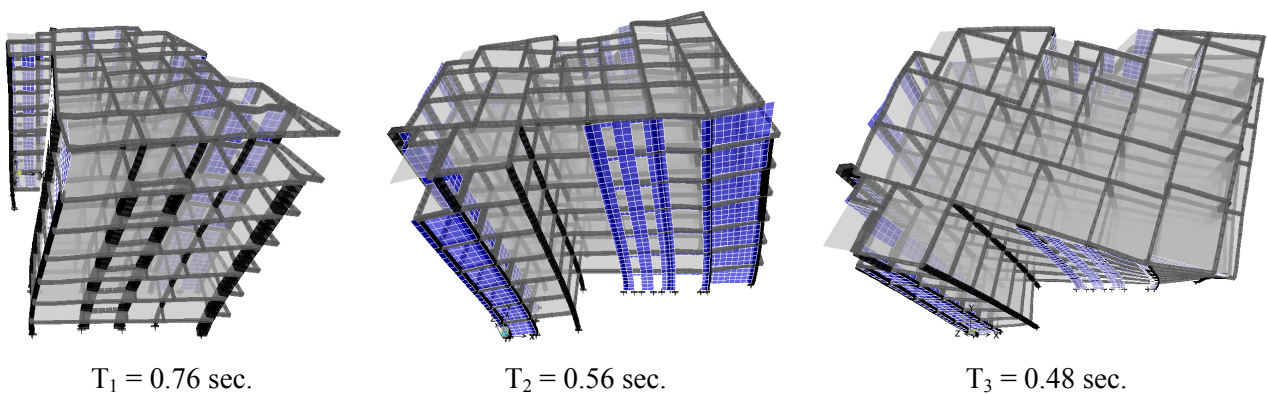
If we compare the results of the modal analysis presented in table 4 with those from table 1, we notice that the retrofitted building is much stiffer than the existing structure and the first mode of vibration is less influenced by torsion, as can be also seen in figure 10.

Figure 10: First three eigen-modes of the retrofitted structure

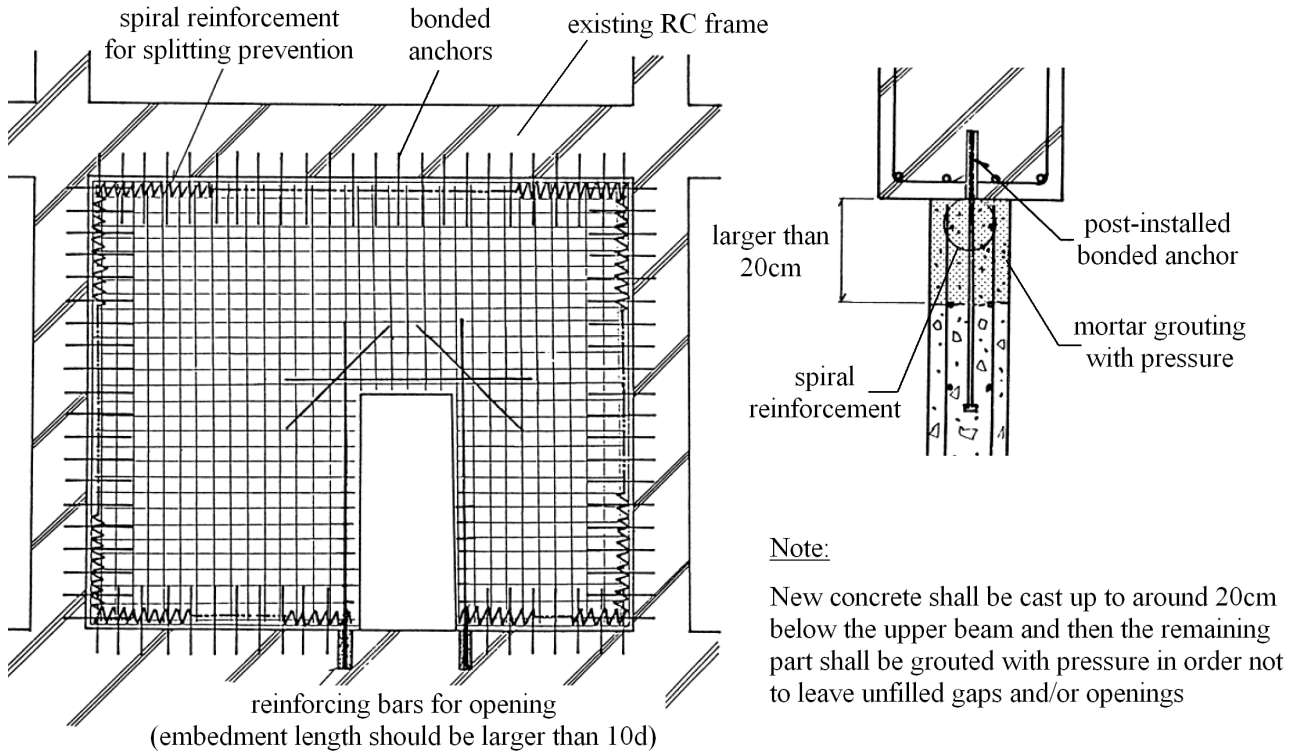
Figure 11: Bar arrangement for a new added interior RC shear wall

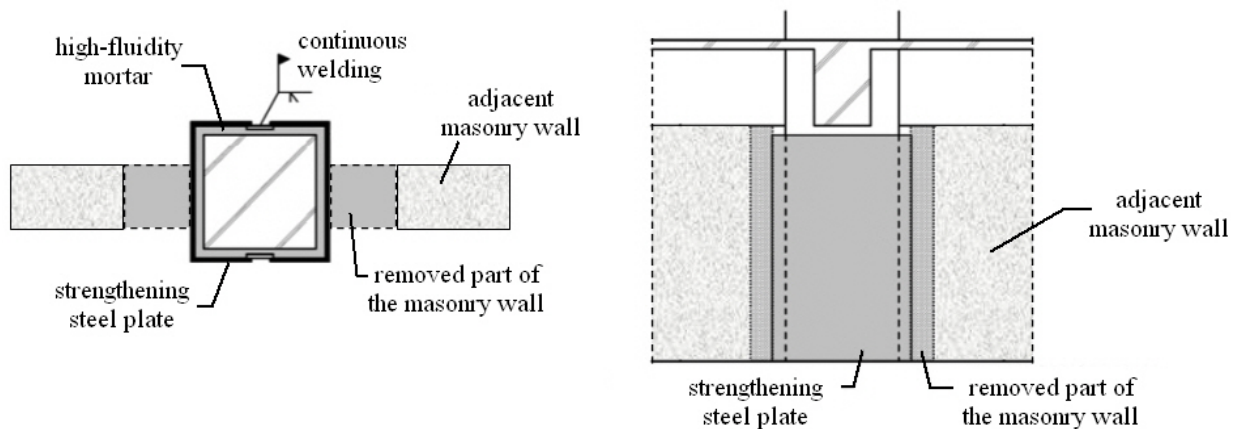
Figure 12: Proposed steel plate strengthening of the existing columns with attached partition walls

Conventional earthquake resistant design of buildings relies on ductility of structural elements to enable redistribution of internal efforts and dissipation of seismic energy. Observations have shown repeatedly the necessity of attention to proportioning, in order to ensure that inelastic deformation occurs at appropriate locations, and detailing, in order to provide adequate ductility in these locations that yield. For this reason, the design team paid a special attention to find the suitable constructive details for the retrofitting project. The Japanese expertise in the field of seismic retrofitting was highly appreciated since it has always provided simple, yet reliable retrofitting details and construction methods. Some of these details are subsequently presented. While, figure 11 presents the connection details between the existing RC frame and the added interior RC walls, the constructive details for steel plate jacketing are presented in figure 12.

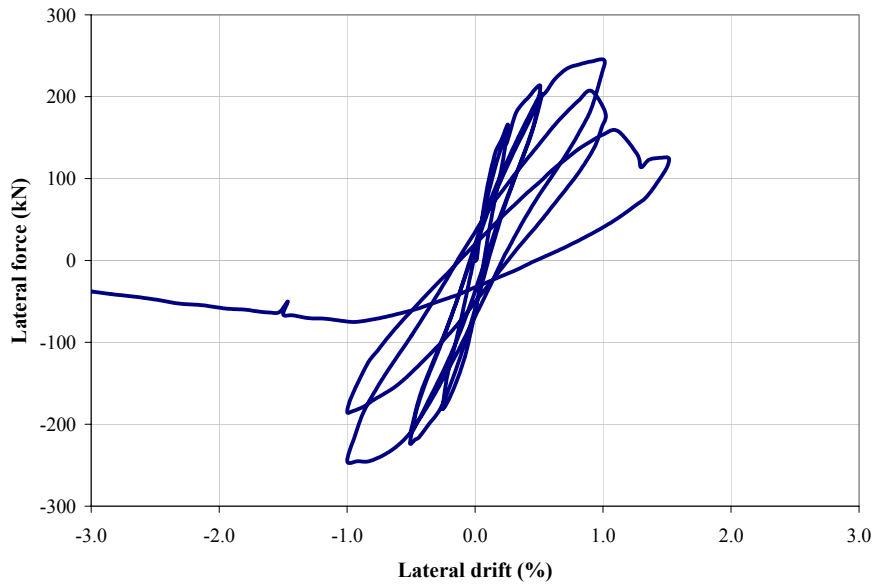
a. As-built RC column

Figure 13: Hysteretic curves before and after steel plate strengthening for an old type pre-1940 RC column

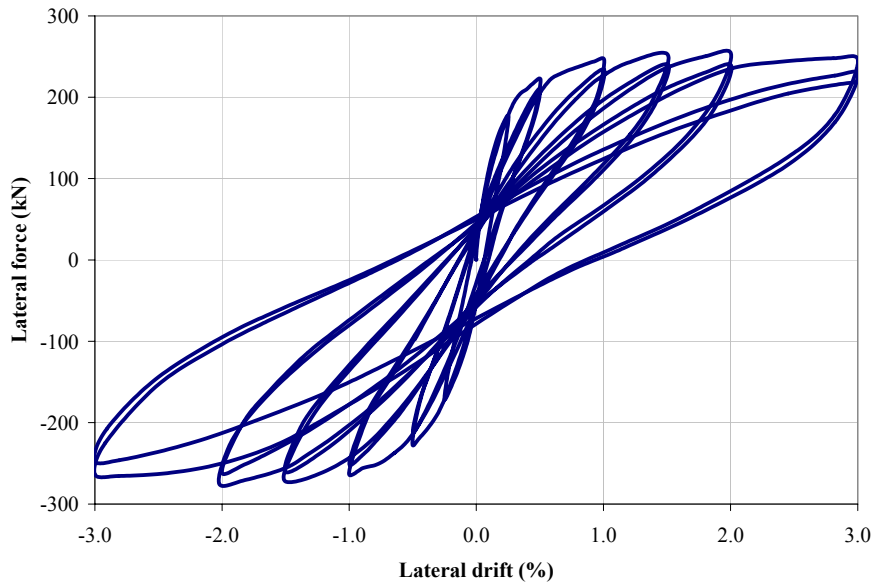
b. Retrofitted column by steel jacking

According to numerous experimental studies, the ductility of the RC columns with poor transverse reinforcement is significantly increased by steel plate jacketing. This was also proved by the experimental tests performed in the structural testing laboratory of the National Center for Seismic Risk Reduction. So, figure 13 presents the differences between the hysteretic curves corresponding to an old type pre-1940 column.
