SEISMIC REHABILITATION OF AN EXISTING PRE-1940 BUILDING. CASE STUDY

SUMMARY

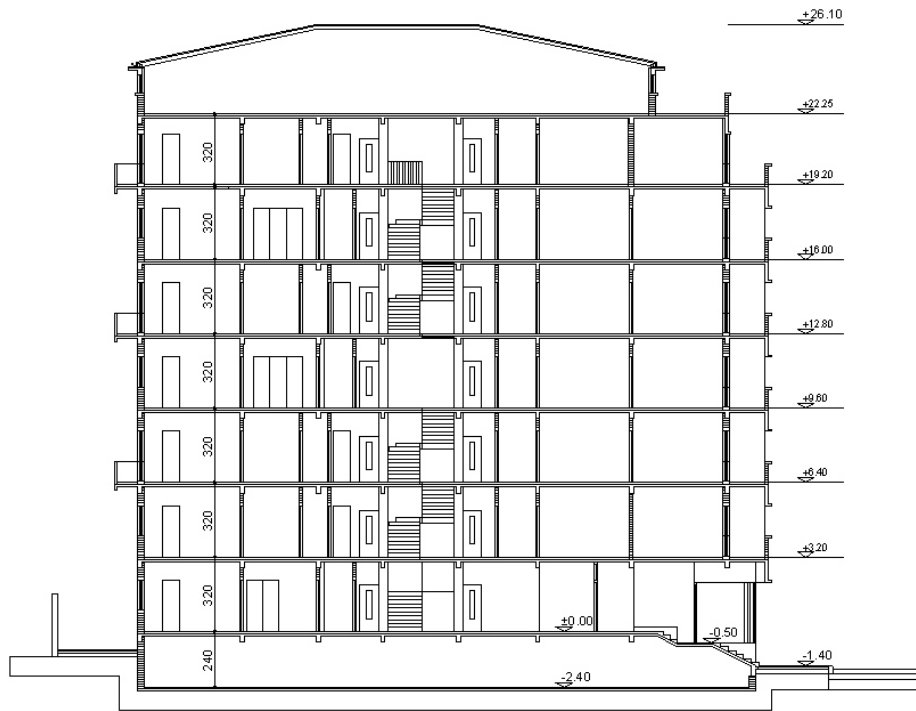
Figure 4: Elevation of the building

The structural system of the building consists of reinforced concrete columns, beams and slabs. According to the Romanian design practice before World War II, the position of the vertical elements resulted only from architectural criteria and, as can be seen in figures 4 and 5, the columns were arranged in a non-uniform pattern. The partition walls are made of brick masonry. The thickness of these interior walls is either 9 or 14 cm. The exterior enveloping walls are 28 cm thick and are also made of brick masonry. The building structure is supported by relatively small reinforced concrete foundation beams.

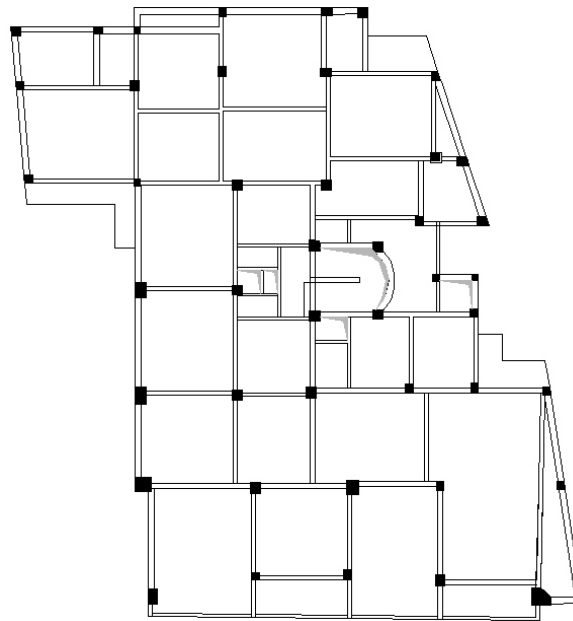
Figure 5: Arrangement of the beams and columns at the second story level

Although in several axes well-defined RC frames can be identified, many beams are supported by other beams and there is a great number of columns that are connected with beams only in one direction, as can be seen in figure 5. In these circumstances it is not appropriate to register this construction as an RC framed building.
